Property Inspection Report
House Detective. Max Koujan
3820 SUN GARDEN DR, TEXAS 75034
(469) 682-4848 FAX (214) 387-7741
house_detective@COMCAST.NET

By: Max Koujan License # 6556 10 / 1 / 2006
(Name and License Number of Inspector) (Date)

The inspection of the property listed above must be performed in compliance with the rules of the Texas Real Estate Commission (TREC).

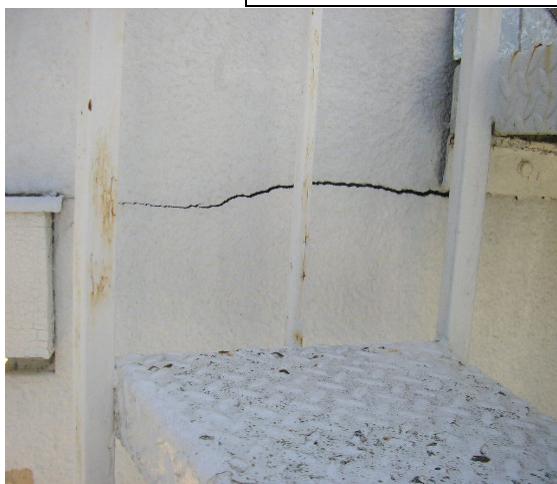
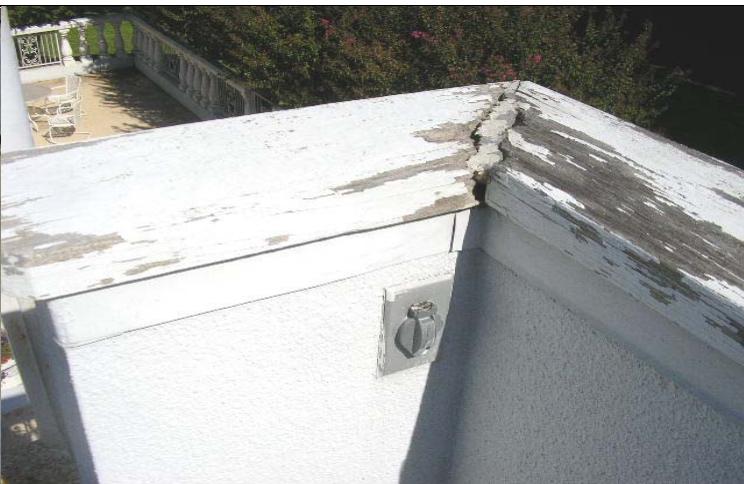
Foundation Performance: FOUNDATION TYPE (SLAB ON GRADE AND PART OF THE HOUSE PIRE AND BEAM) THE FOUNDATION WAS OBSERVED FROM OUTSIDE THE HOUSE AND INSIDE AND UNDER, THEIR IS SETTLEMENT AND MOVEMENT ON CABANA WALL AND SOME SETTLEMENT IN HOUSE. STUCCO WALLS HAVE SEPERATION NOTED ON SEVERAL AREAS AROUND THE HOUSE. I RECOMMEND FOUNDATION COMPANY OR STRUCTURAL ENGINEER TO INSPECTION AND EVALUTED THE ENTRGRITY OF THE FOUNDATION

This inspector is not a structural engineer. The client should have an engineer give an evaluation if any concern exists about the potential for future movement.

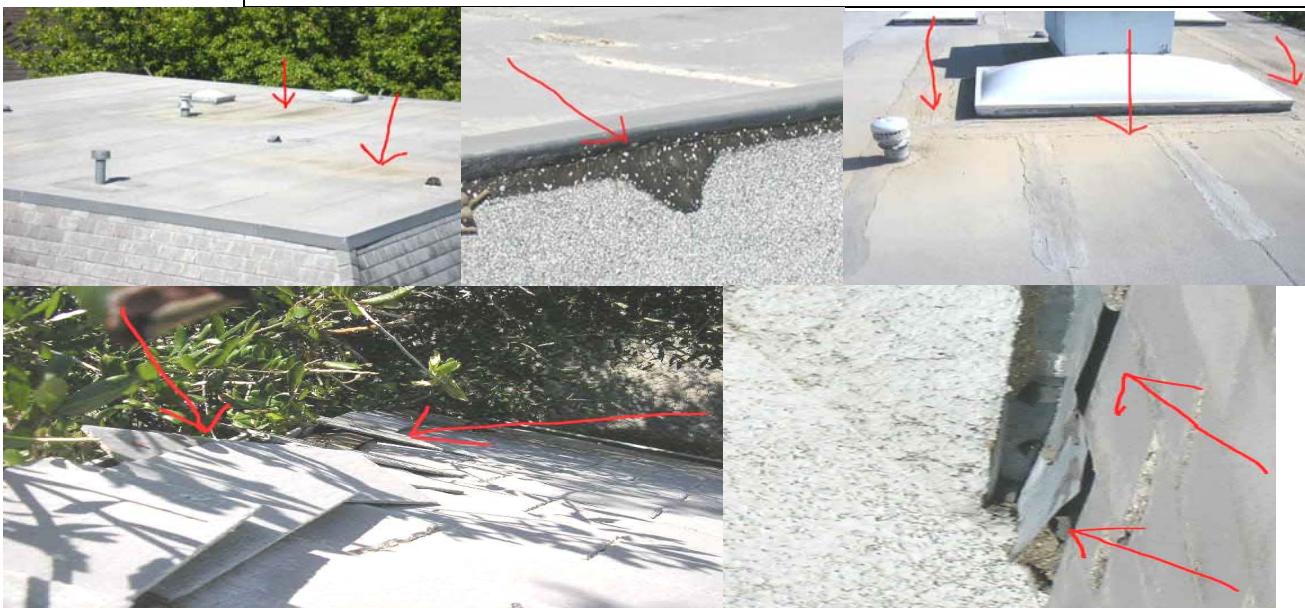
ROOF IS MANSARD TYPE: FLAT ROOF AND SLATE AROUND THE SIDES. .SOME SHINGLES ARE COMING LOOSE. . ABOVE ARCH WINDOWS NEED TO BE CAULKED. STEP FLASHING IN NEED OF REPAIR IN SOME PARTS. TREE BRANCHES ARE TOO CLOSE TO ROOF . SIGN OF WATER PONDING IS EVIDENT. SLOPE NEEDS TO BE CORRECTED. I RECOMMEND ROOFING COMPANY TO INSPECT AND MAKE THE NECESSARY REPAIRS.

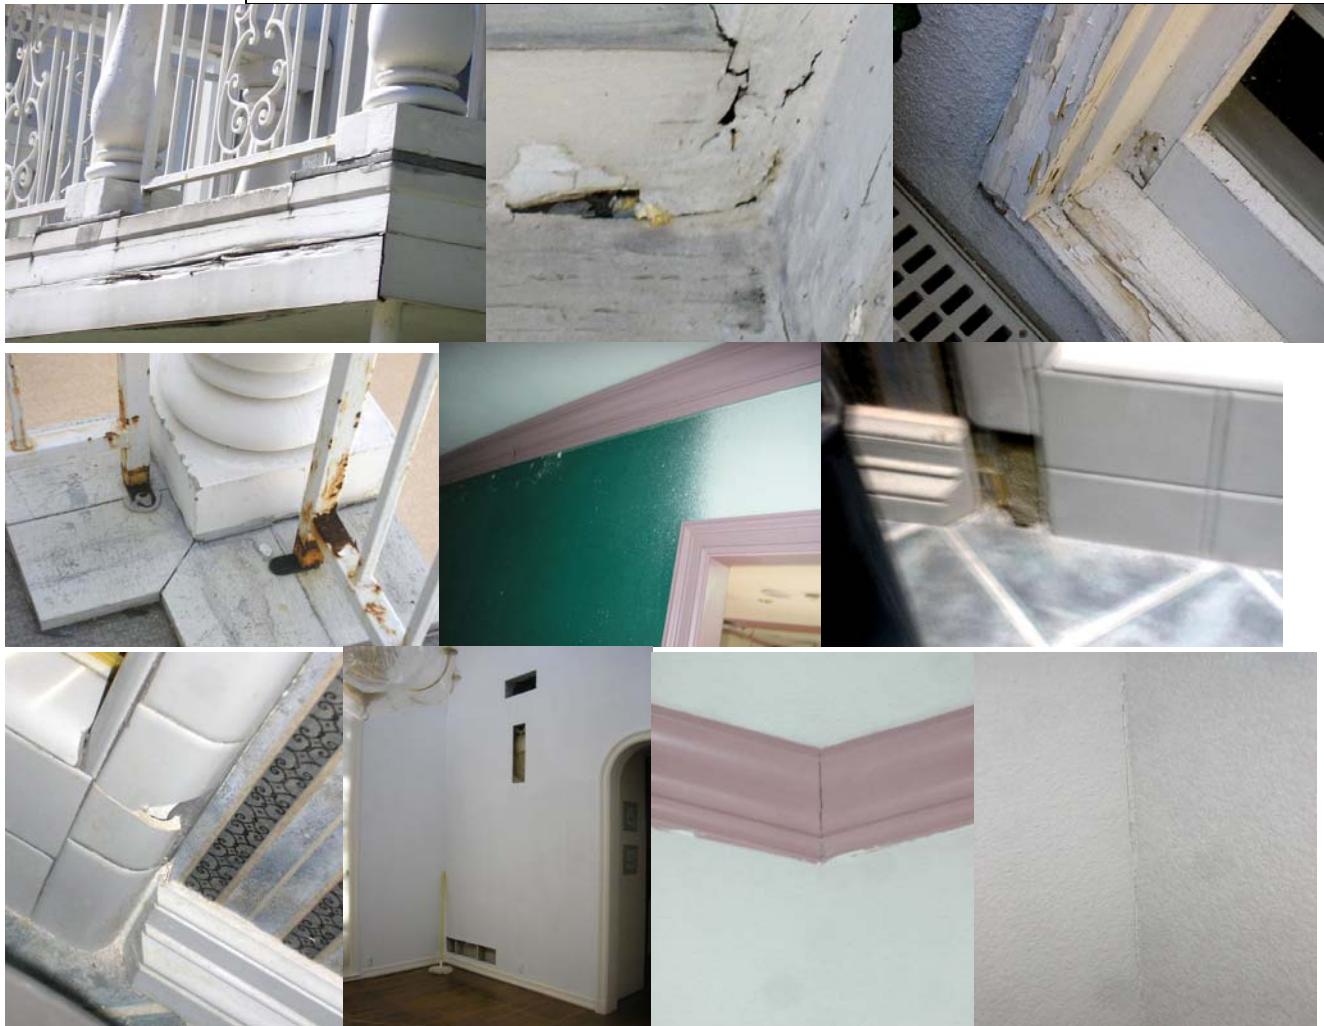
INTERIOR: STAIR HAND RAIL IS LOOSE. SOME STRESS CRACKS NOTED. DINING ROOM VENT COVERS NOT INSTALLED. SOME WALLS IN PROCESSS OF PAINTING. LEFT SIDE BEDROOM BATHROOM TILE COMING LOOSE.

SOME CRACKS AT STUCCO SIDING. ALL WOODON WINDOWS,BALCONY, DOORS PAINT COMING OFF AND SOME ARE DAMAGED. MOST THE GUARD RAILS ARE RUSTED.

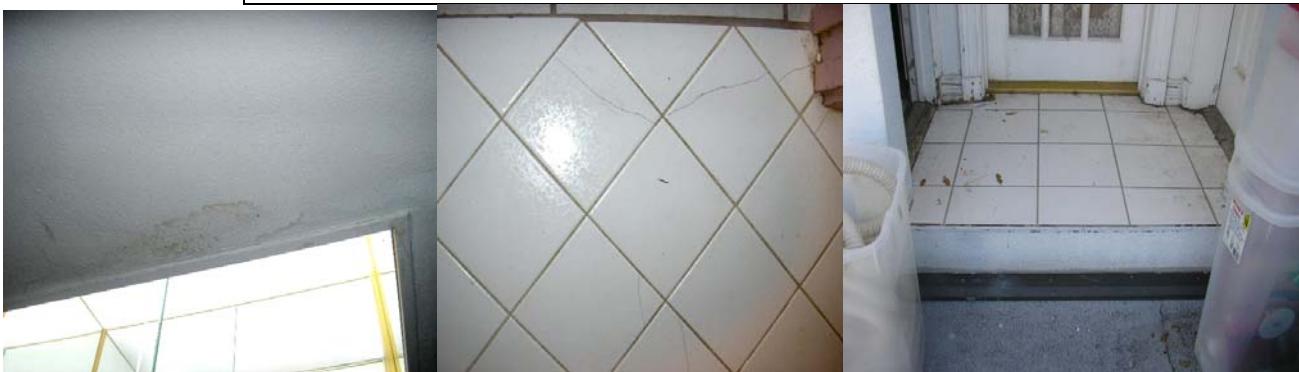
CEILING: SOME STRESS CRACKS NOTED IN SOME CEILINGS. PREVIOUS WATER LEAK MARKS AND REPAIR NOTED ON MASTER BEDROOM AND BATHROOM CEILING. HAIR LINE SEPARATION ABOVE BACK YARD DOOR.
FLOORS: - TILES IN CABANA BATHROOM ARE CRACKED AND ONE IN ENTRANCE HALL. TILES OVER CABANA, OUT SIDE MASTER BEDROOM BACK DOOR ARE SLOPING TOWARDS THE DOOR, CAUSING THE WOOD FRAME TO ROT. TILE IN MASTER BATHROOM NEEDS TO BE GROUTED AROUND THE EDGE.

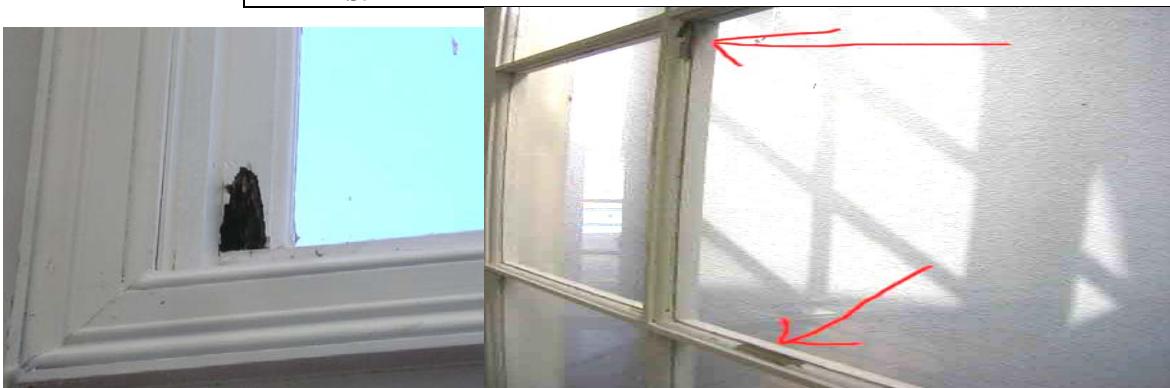
ALL DOWN STAIRS WINDOWS DO NOT OPEN, CAN BE SAFETY HAZARD IN CASE OF EMERGENCY. SOME WINDOWS NEED TO BE CAULKED FROM THE INSIDE AND OUTSIDE. MOST WINDOW LEDGES HAVE WATER DAMAGE OR PAINT COMING OFF. I RECOMMEND WINDOW COMPANY TO INSPECT AND MAKE THE NECESSARY REPAIRS.

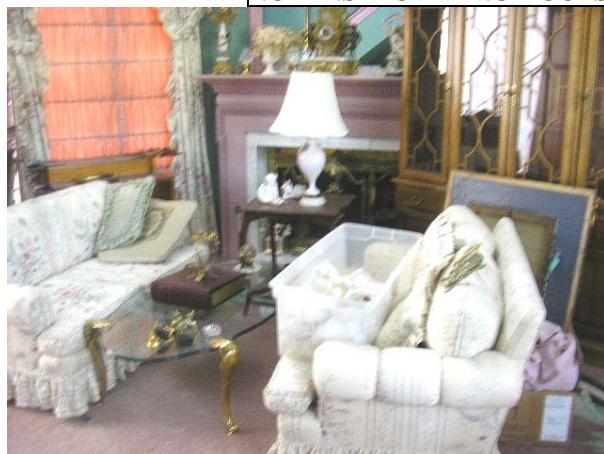
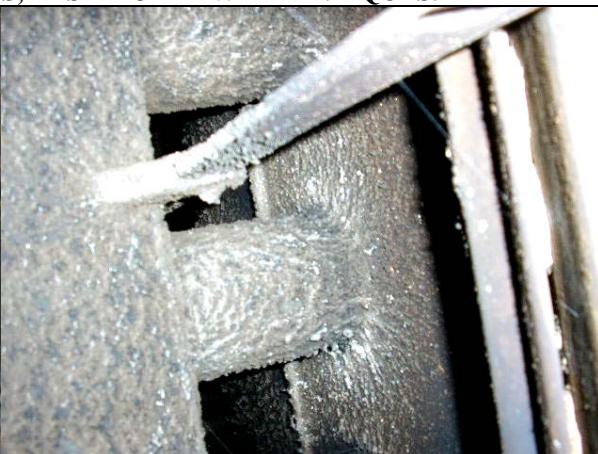
C CLAMP NEEDED ON DAMPER ON MASTER BATHROOM FIRE PLACE. MEDIA ROOM CHIMNEY FLUE NEEDS TO BE CLEANED. FIRE PLACE IN LIVING ROOM IS NOT INSPECTED NO ACCESS, RESTRICTED WITH ANTIQUES.

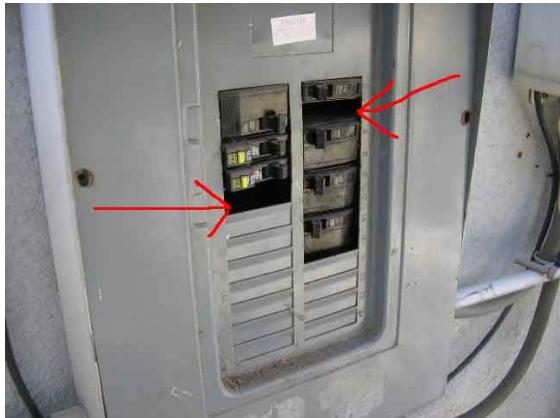
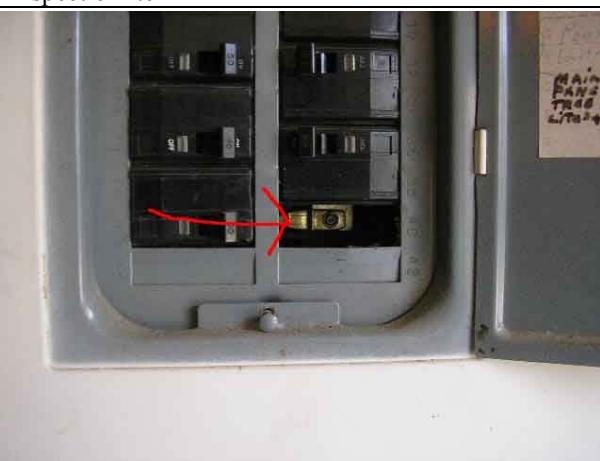
MAIN PANEL BOX IN GARAGE. AND THERE ARE 5 SUB PANELS 3 – IN GARAGE NORTH SIDE AND 2- IN GARAGE WEST SIDE. THERE IS EMPTY SPACE BETWEEN BREAKER NEEDS TO BE COVERED AND LABELED.

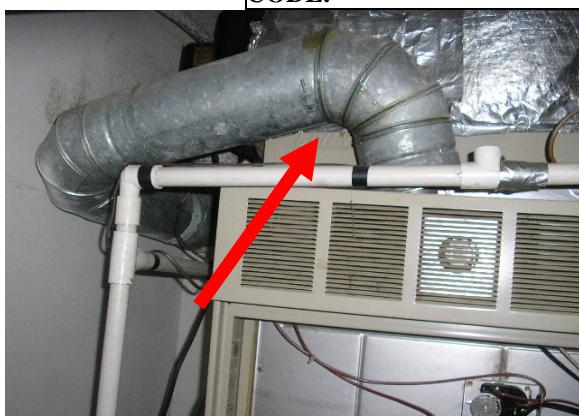
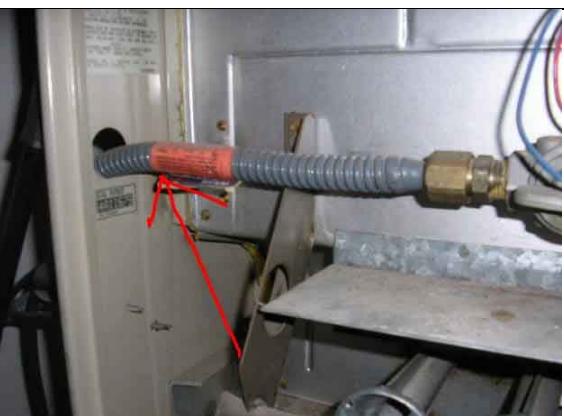
UNIT IN GARAGE FLUE VENT IS NOT PROPERLY INSTALLED, NEEDS TO BE UP TO CODE. FLEX GAS LINE ENTERING UNIT CASING NEEDS TO BE SOLID. I RECOMMEND THAT ALL THE UNITS BE INSPECTED SERVICED BY A LICENSED HVAC COMPANY AND MAKE ALL THE NECESSARY REPAIRS AND BRING IT UP TO CODE.

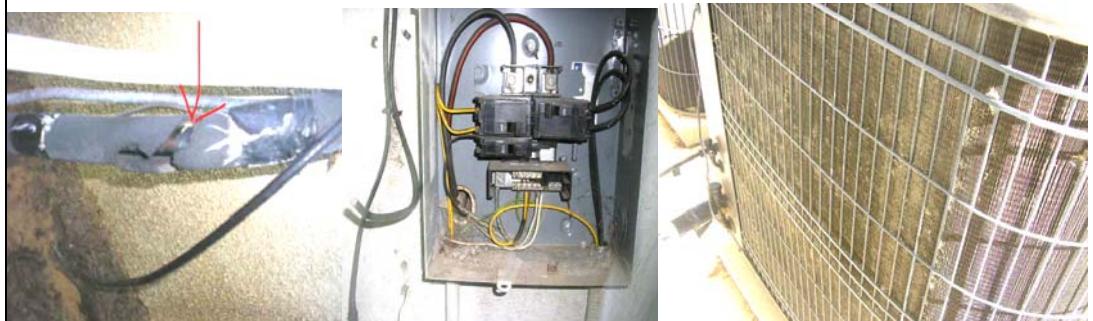
RAN UNIT 50 MINUTES I RECEIVED 5 – 10 DEGREES DIFFERENTIAL ON ALL UNITS WHAT SHOULD BE 15 – 20 DEGREES. ALL CONDENSING COILS NEED TO BE CLEANED. INSULATION AROUND COOLING LINE NEEDS TO BE REPLACED. RUST ON DRAIN PAN. I RECOMMEND EVAPORATOR COIL TO BE INSPECTED AND TO BE CLEANED. CHECK THE AIR FLOW ON ALL UNITS. CUT OFF BOX MISSING COVER ON WEST SIDE UNITS.

I RECOMMEND THAT THE UNIT BE INSPECTED SERVICED BY A LICENSED HVAC COMPANY AND MAKE ALL THE NECESSARY REPAIRS.

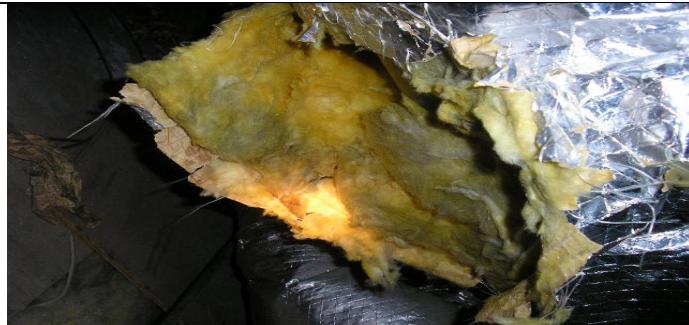
AIR LEAKS AROUND DUCTS AND UNITS IN ATTIC. PART OF INSULATION IS TORN.

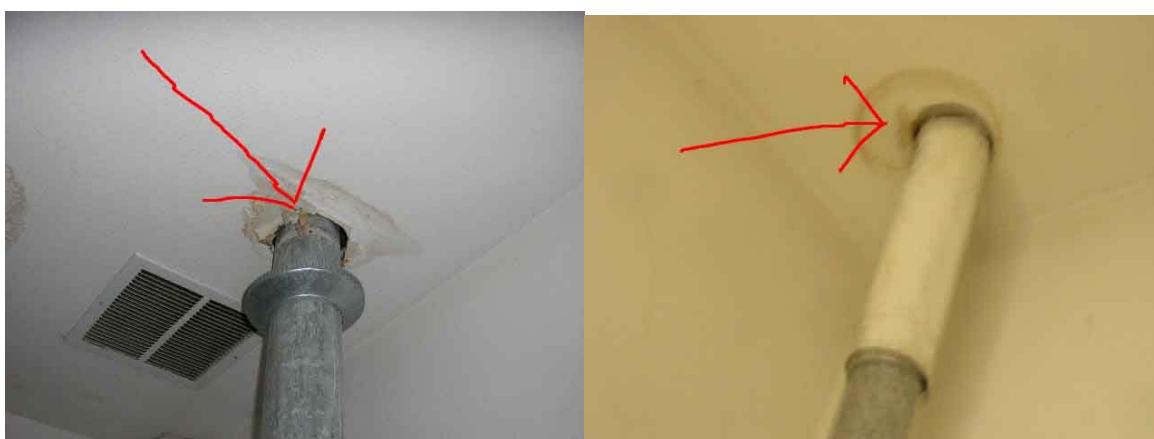
4-HOT WATER HEATERS 2- ELECTRIC AND 2- GAS, IN GARAGE LOCATION IS ROOM NEXT TO MASTER BEDROOM. ELECTRIC IN ATTIC AND IN THE CAPANA. GAS WATER HEATER VENT PIPE CELLING PLATE COMING LOOSE AND ONE MISSING. I RECOMMEND PLUMBING COMPANY TO INSPECT AND MAKE THE NECESSARY REPAIRS.
